Manhole Inspection Summary

Manhole # S17I1_002MH

Insp Date: **4/23/08 12:42 PM**

Location Address: **2228 nieman av**

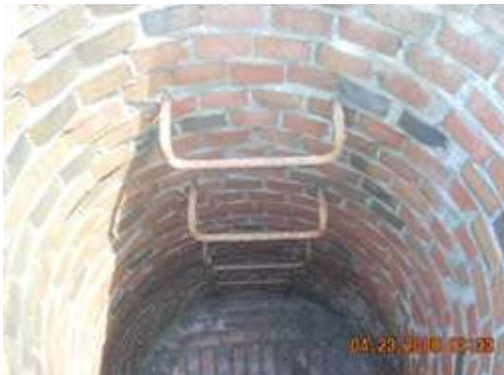
Defect 2

Count: **5** Missing: **0** ☒ **Corroded**

corroded steps

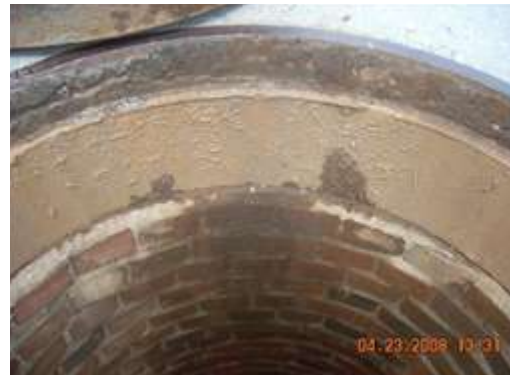
Defect 1

Infiltration: ☐ None ☒ **Joint** ☐ Cracks ☐ Mortar ☐ Roots ☐ Wall

infiltration @ corbel/frame joint

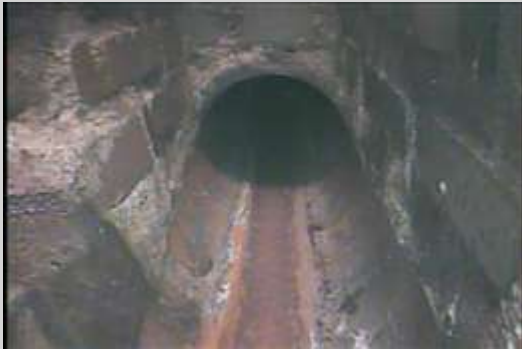
12 O'Clock Outflow

8 in. Circular Gravity Sewer
Pipe Out @ 12 O'Clock

Pipe Height: **8.4** (in.) Rod and Bar (Angled)
Pipe Material: **Clay** ☐ Pipe Lined
Invert Depth: **10.11** (ft.) Flow Characteristics: **Slow**
Deposits: ☒ None ☐ Mud ☐ Sludge ☐ Debris ☐ Grease
Silt Depth: **0** (in.) Deposits Extent:
Infiltration: **None** Pipe Seal Cond: **Sound**

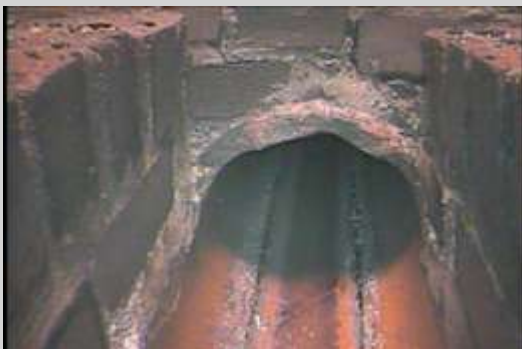
6 O'Clock Inflow

8 in. Circular Gravity Sewer
Pipe In @ 6 O'Clock

Pipe Height: **8.4** (in.) Rod and Bar (Angled)
Pipe Material: **Clay** ☐ Pipe Lined
Invert Depth: **9.73** (ft.) Flow Characteristics: **Slow**
Deposits: ☒ None ☐ Mud ☐ Sludge ☐ Debris ☐ Grease
Silt Depth: **0** (in.) Deposits Extent:
Infiltration: **None** Pipe Seal Cond: **Sound**

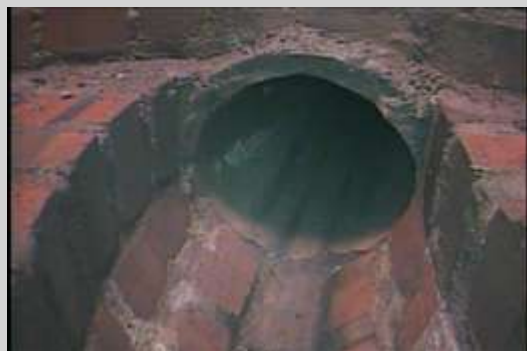
9 O'Clock Inflow

Infiltration: **None** Pipe Seal Cond: **Sound**
